**Infinitum 6013**

FACING BRICKS CATEGORY I, U

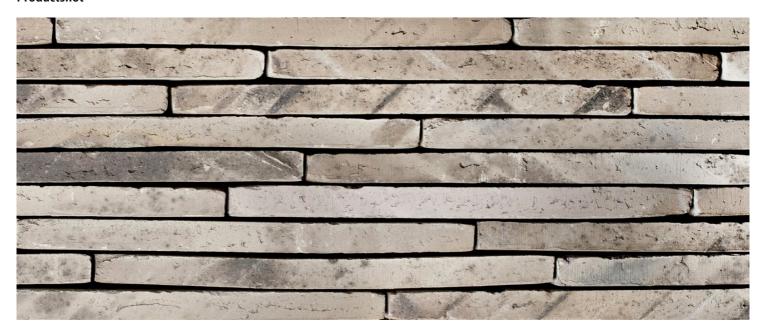
# Productshot

The decorative brickwork (inside and/or outside face) is made with a solid unsanded moulded brick without grain with a very uneven structure. Due to the natural reduction with coal the bricks have a strong fired rough field fire aspect. Some visible sides of the brick also contain traces of coal and of the manual production method. The colour is light green-grey to brown-grey with a black-grey surface structure.
