linea 3016

FACING BRICKS
CATEGORY I, U

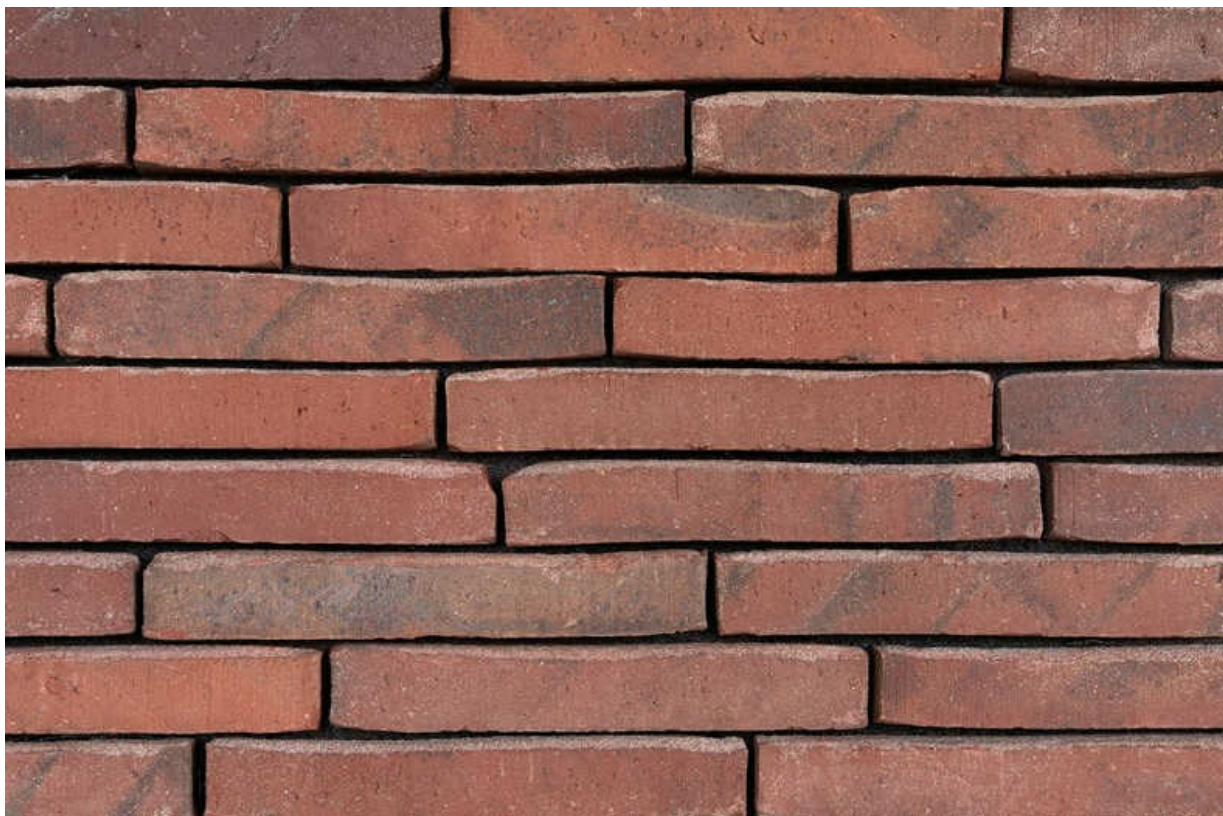
Productshot

The decorative brickwork (inside and/or outside face) is made with a solid unsanded moulded brick without grain with a very uneven structure. Due to the natural reduction with coal the bricks have a strong fired rough field fire aspect. Some visible sides of the brick also contain traces of coal and of the manual production method. The colour of the body is coral to brown-red with nuances.
