# linea 3016

## TEXTURE, TYPE & COLOUR

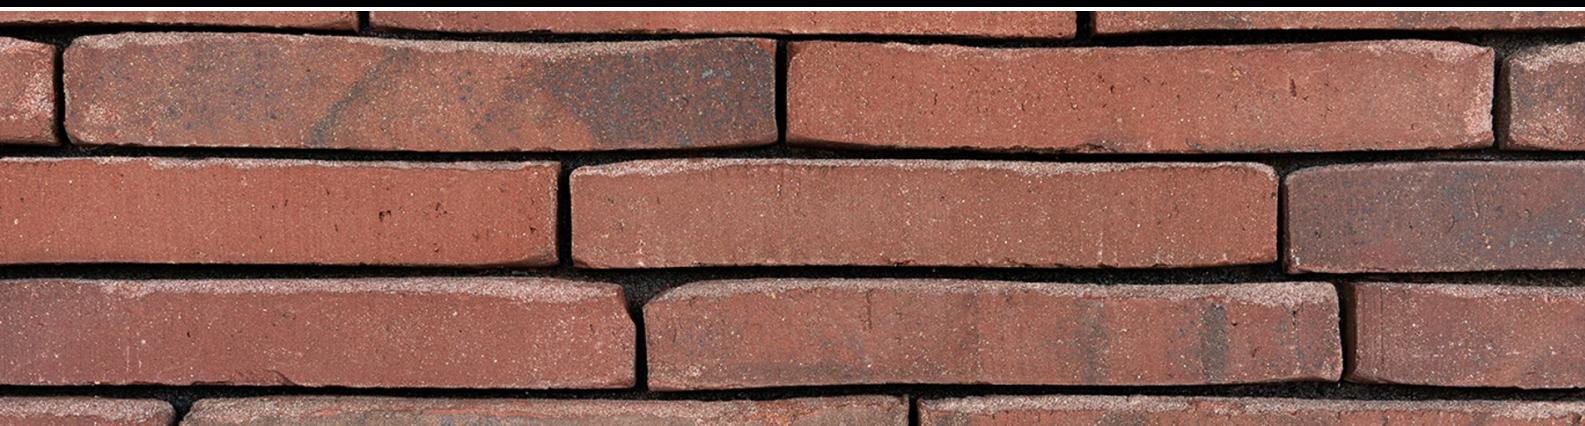
The decorative brickwork (inside and/or outside face) is made with a solid unsanded moulded brick without grain with a very uneven structure. Due to the natural reduction with coal the bricks have a strong fired rough field fire aspect. Some visible sides of the brick also contain traces of coal and of the manual production method. The colour of the body is coral to brown-red with nuances.
