N10 Brick E

FACING BRICKS
CATEGORY I, U

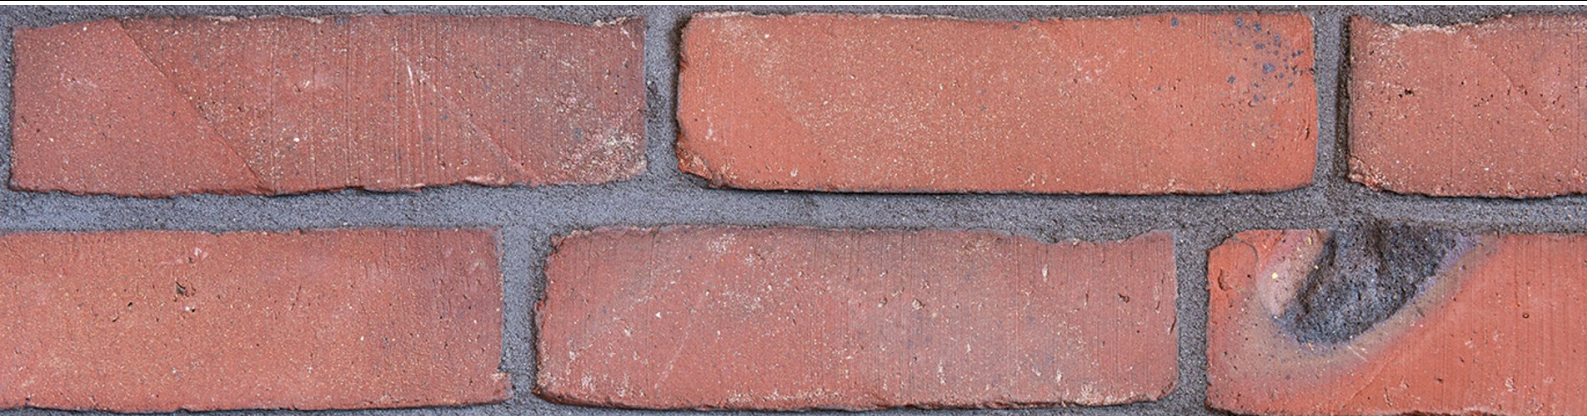
The decorative brickwork (inside and/or outside face) is made with a solid unsanded moulded brick without grain with a very uneven structure. Due to the natural reduction with coal the bricks have a strong fired rough field fire aspect. Some visible sides of the brick also contain traces of coal and of the manual production method. The colour of the body is red with strong red and red-brown to purple-blue nuances.
