### **TEXTURE, TYPE & COLOUR**

# N10 Brick J

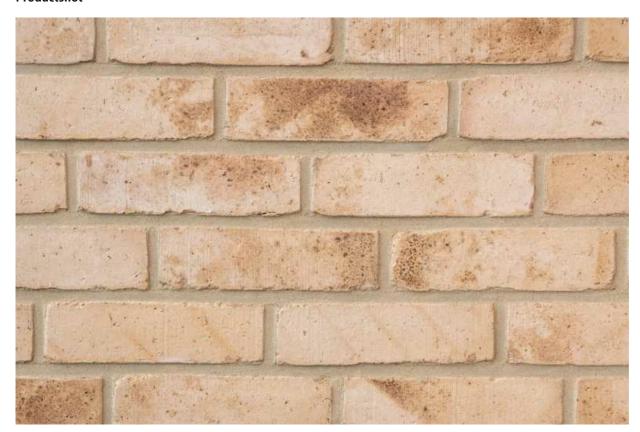
## Productshot

The decorative brickwork (inside and/or outside face) is made with a solid unsanded moulded brick without grain with a very uneven structure. Due to the natural reduction with coal the bricks have a strong fired rough field fire aspect. Some visible sides of the brick also contain traces of coal and of the manual production method. The colour of the body is cream and nuanced from cream to ecru.
