N10 Brick M

FACING BRICKS

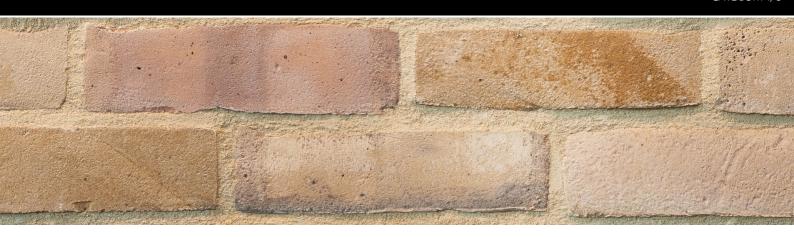
The decorative brickwork (inside and/or outside face) is made with a solid unsanded moulded brick without grain with a very uneven structure. Due to the natural reduction with coal the bricks have a strong fired rough field fire aspect. Some visible sides of the brick also contain traces of coal and of the manual production method. The colour of the body is yellow ochre.
