# N10 Brick V

## TEXTURE, TYPE & COLOUR

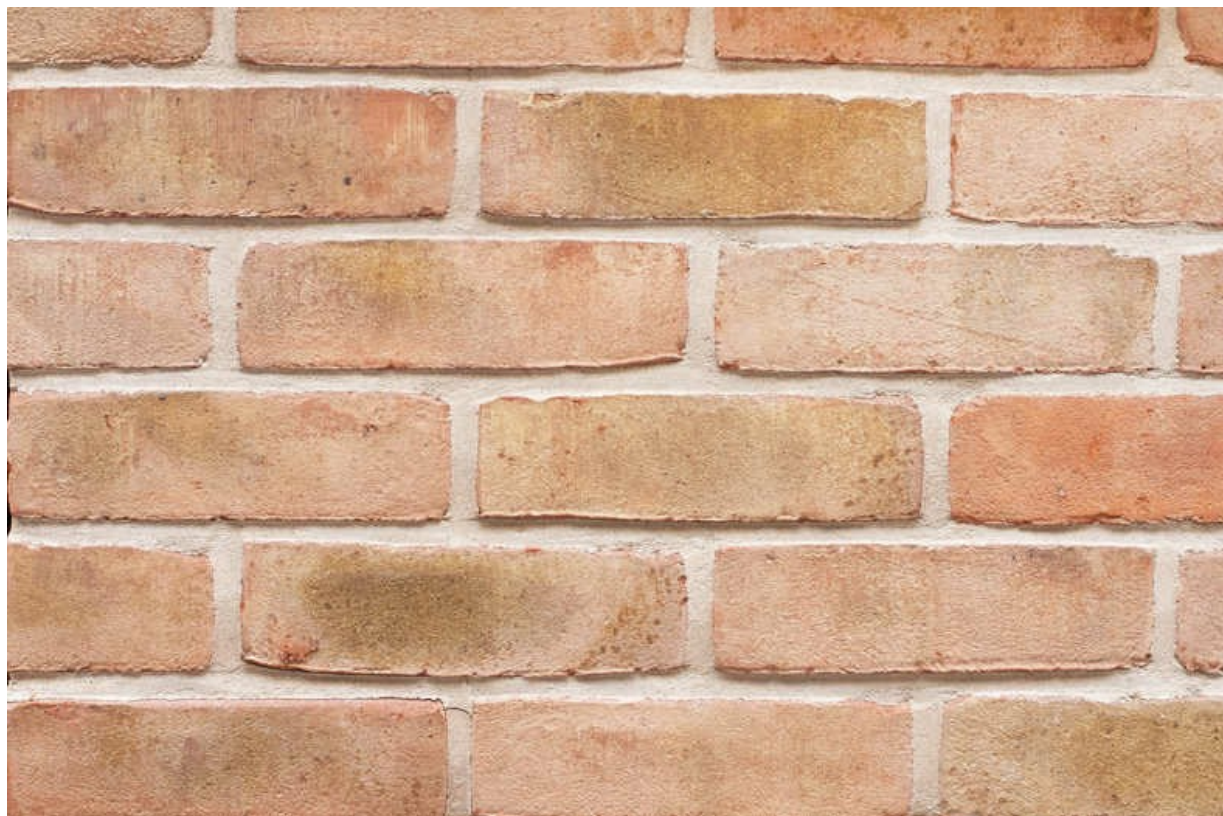
## Productshot

The decorative brickwork (inside and/or outside face) is made with a solid unsanded moulded brick without grain with a very uneven structure. Due to the natural reduction with coal the bricks have a strong fired rough field fire aspect. Some visible sides of the brick also contain traces of coal and of the manual production method. The colour of the body is soft orange-red with an irregular beige-white surface texture.

This entirely natural product is made of alluvial clay from the Quaternary from the Scheldt valley. The brick is formed in a unsanded mould by putting in a lump of clay and is fired at at least 1150 °C. The facing brick is a solid moulded brick and has a homogeneous structure. It is free from lime and other inclusions and has at least one stretch and one head which are free from cracks and other aspects which negatively affect the overall appearance of the brickwork.
