FACING BRICKS CATEGORY I, U

14-09-2025

# **Brick A**

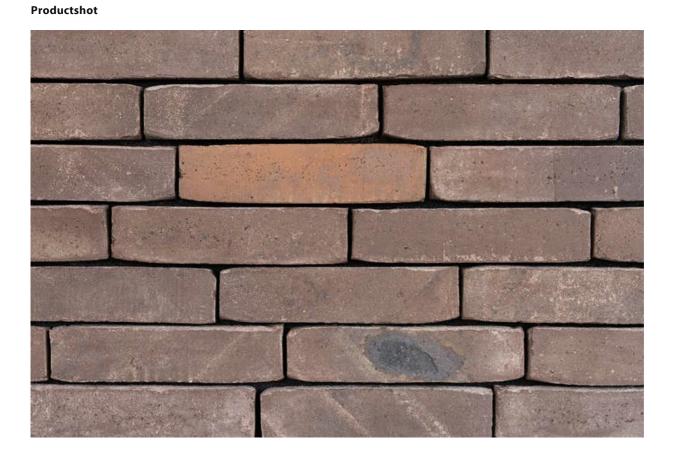
The decorative brickwork (inside and/or outside face) is made with a solid unsanded moulded brick without grain with a very uneven structure. Due to the natural reduction with coal the bricks have a strong fired rough field fire aspect. Some visible sides of the brick also contain traces of coal and of the manual production method. The colour of the body is brown with strong brown to purple-blue nuances.
