Brick E

TEXTURE, TYPE & COLOUR

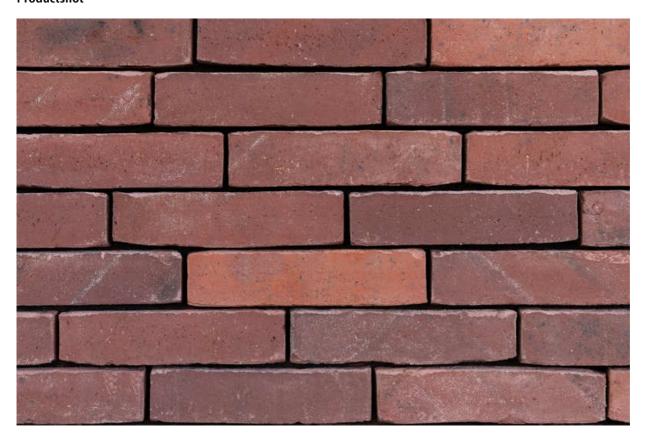
Productshot

The decorative brickwork (inside and/or outside face) is made with a solid unsanded moulded brick without grain with a very uneven structure. Due to the natural reduction with coal the bricks have a strong fired rough field fire aspect. Some visible sides of the brick also contain traces of coal and of the manual production method. The colour of the body is red with strong red and red-brown to purple-blue nuances.
