# Veldbrand Red

## TEXTURE, TYPE & COLOUR

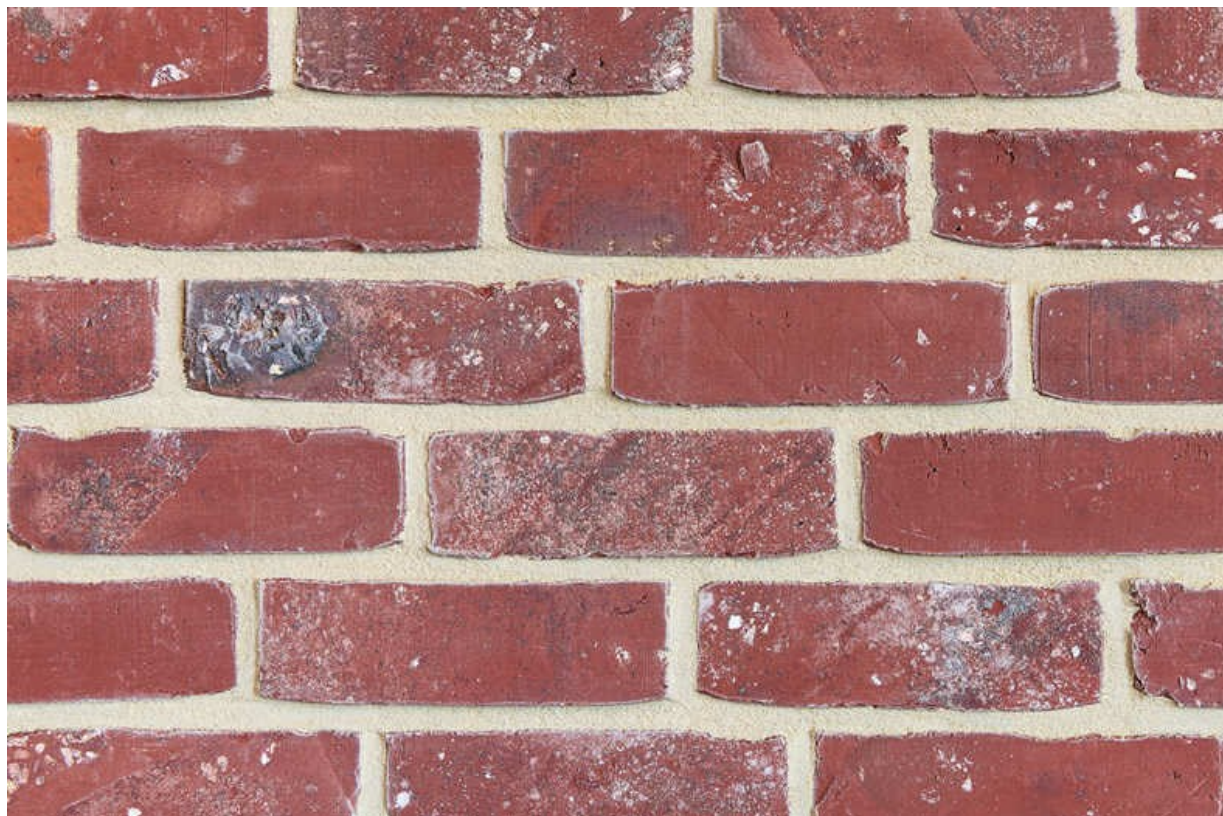
## Productshot

The decorative brickwork (inside and/or outside face) is made with a solid unsanded moulded brick without grain with a very uneven structure. Due to the natural reduction with coal the bricks have a strong fired rough field fire aspect. Some visible sides of the brick also contain traces of coal and of the manual production method. The colour is red-brown to violet-blue with nuances.
